SUMMARY OF THE CONSERVATION TREATMENTS TO COOPER'S ROW, LONDON CITY WALL, UK, 2013-2015

Jonathan Kemp*

The article sets out a record of the conservation methods and materials employed during the works to this section of the wall between 2013 and 2015. A summary of the treatments is included below, with each year's program of works consisting of 40, 30, and 30 days per year respectively.

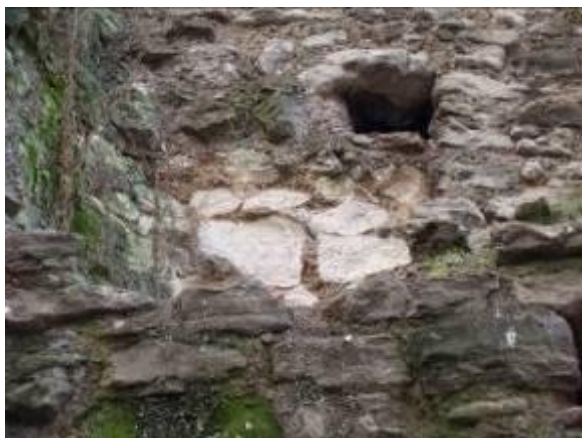
Zone M2: Overall this zone is well consolidated at the upper level but cracks in the pointing are being colonised by bio-infestation. The upper opening is a roost for pigeons and has accumulated guano, as have many of the horizontal surfaces on this elevation of the wall. The arch of the opening has some continuing deterioration, and areas of the exposed chalk core continue to deteriorate even after consolidation in 2001 (Figure 10).

Figure 10 - Detail of M2 showing active chalk decay, plant/bio-infestation and putlock hole, west elevation

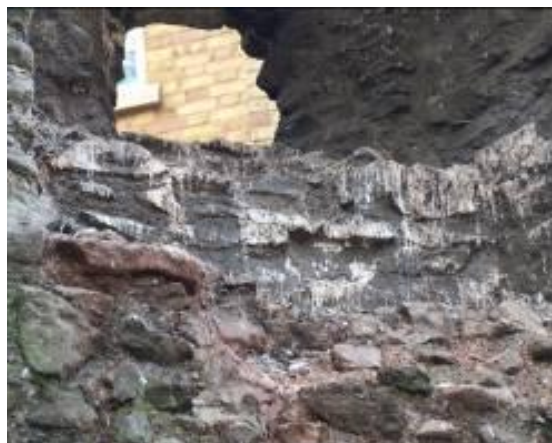
Zone M4: In this zone, there is minor vegetation on the wall head and higher levels, with most of the wall surface covered in algae. There is a large arched opening which has some decay to stones in the soffit. Pigeons use the 'putlock' holes and there is brown staining and guano deposits evident (Figure 11). There is some ongoing decay of the exposed chalk, and also deterioration to some of the facing stones and one section of detaching MoW mortar.

Figure 11 - Detail of M4 opening covered in guano, west elevation

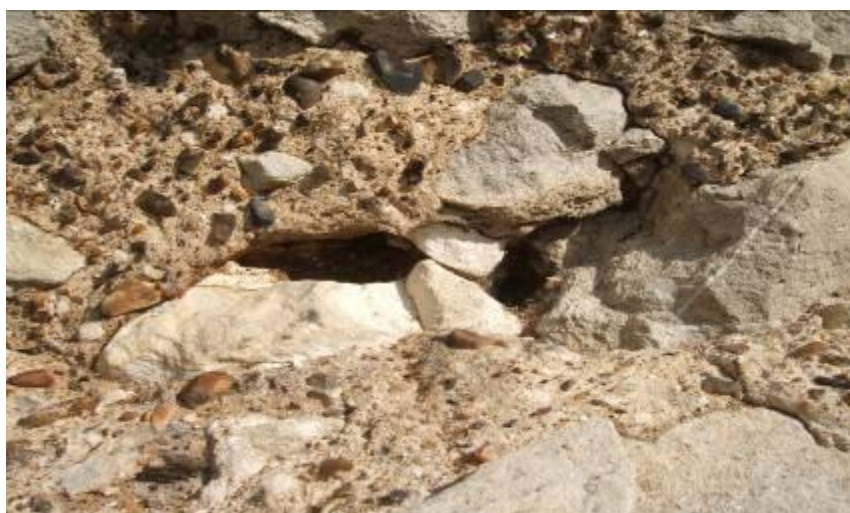
Zone M3: There is some cracking between stones and the MoW mortar in this zone (Figure 12). Vegetation has become established on the horizontal surfaces of the V-shaped offset, including moss and buddleia. Just beneath this offset on the extreme north of the zone is an area of exposed core where pigeons are roosting and appear to have pecked at the soft stone; an adjacent area of chalk blocks suffers decay and adjacent areas of the MoW consolidated core exhibit sulphation (Figure 13).

Figure 12 - Detail of cracks between stones and MoW pointing, west elevation

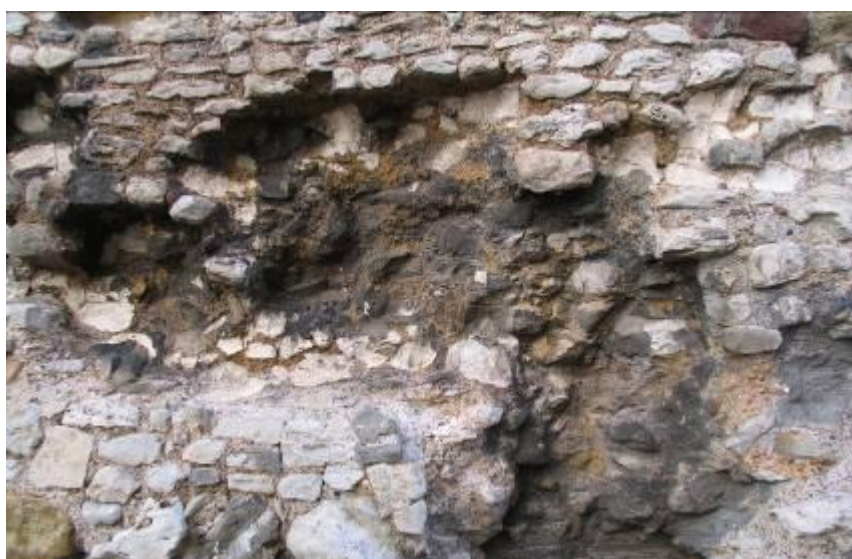
Figure 13 - Detail of chalk decay, sulphation and MoW cement pointing, zone M3, west elevation

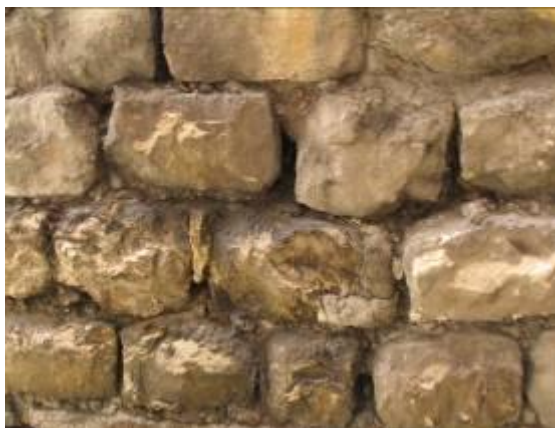
Zones R1/R2: Stonework is generally good and the tile courses preserved and in place. However the pointing, although re-pointed in places, is generally missing with large voids present. There is some exposed core to the north end adjacent to the pedestrian walkway.

Figure 14 - Detail of pointing losses and voids, east elevation

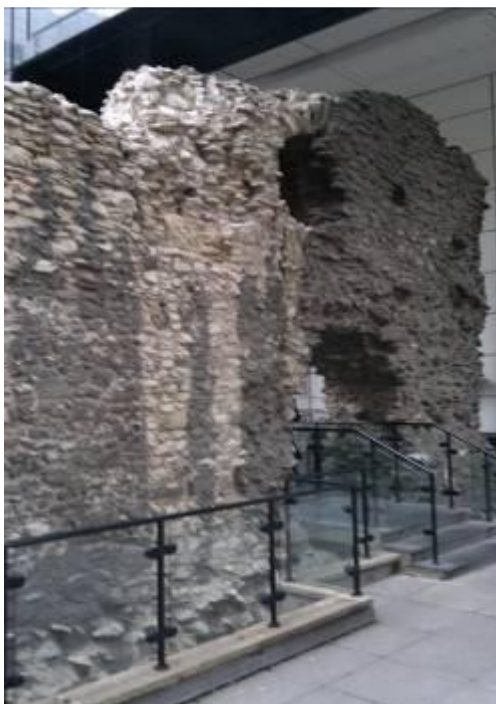
Zone M1: The north end of this zone is sulphated but in good condition. The area around the opening is sound and the area around the upper opening was consolidated as part of the works in 2001 and seems stable. There is no vegetation on the horizontal ledges but there is some irregular staining caused by water run off (Figure 16).

Figure 16 - Looking north along zones M1 - M2, east elevation

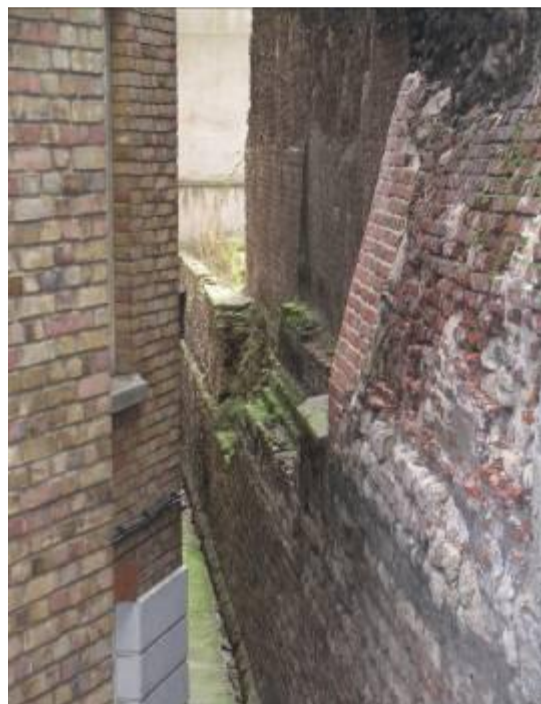
vertical face. The upper section of the masonry is irregular and the pointing is deleterious in places (Figure 17).

Figure 17 - Looking south along zones M3, M5, east elevation

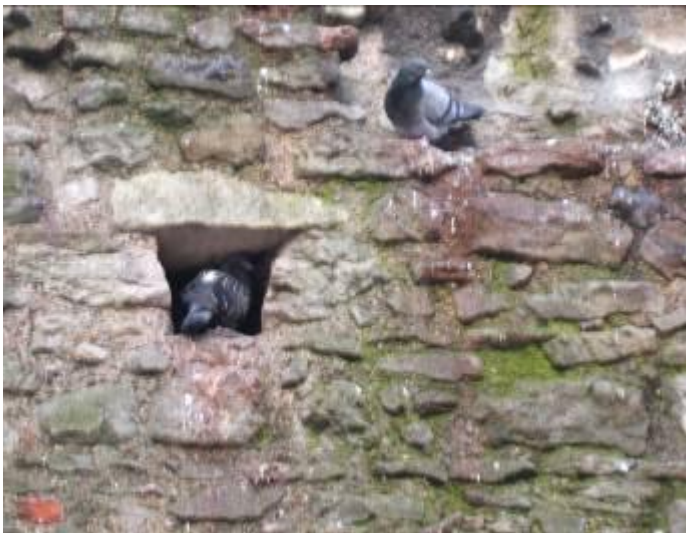
Figure 20 - Pigeons nesting in putlock holes, west elevation

Works in 2013 ensured that all the putlock holes used as nesting areas by pigeons were closed by the fabrication of handmade galvanised mesh cages. One nesting hole on the East Elevation was closed off in the 2014 works, having been unreachable during the 2013 conservation season (Figures 20 and 21). Extensive guano deposits were removed in 2013 using trowels and the ThermaTech® super-heated water cleaner, and in subsequent years using trowels and conservation-grade steamcleaners. Although pigeon activity has declined over the period 2013-2015 because of the blocking of the nest holes, there is still a significant build up of guano deposits in the major openings and ledges of the wall. Some newer sites for such deposits were noted in 2015 as the birds habitual roosting areas were made inaccessible.

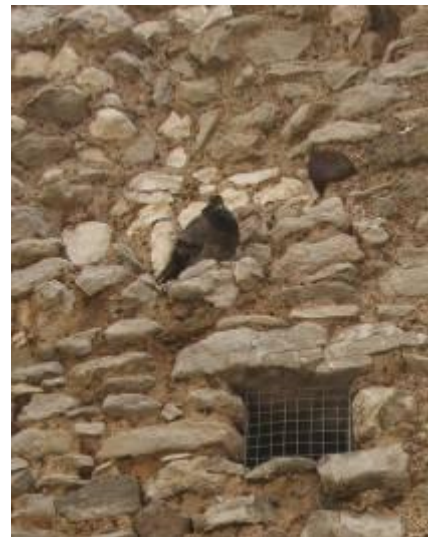
Figure 21 - Pigeons denied access to putlock holes by galvanised wire cages, west elevation

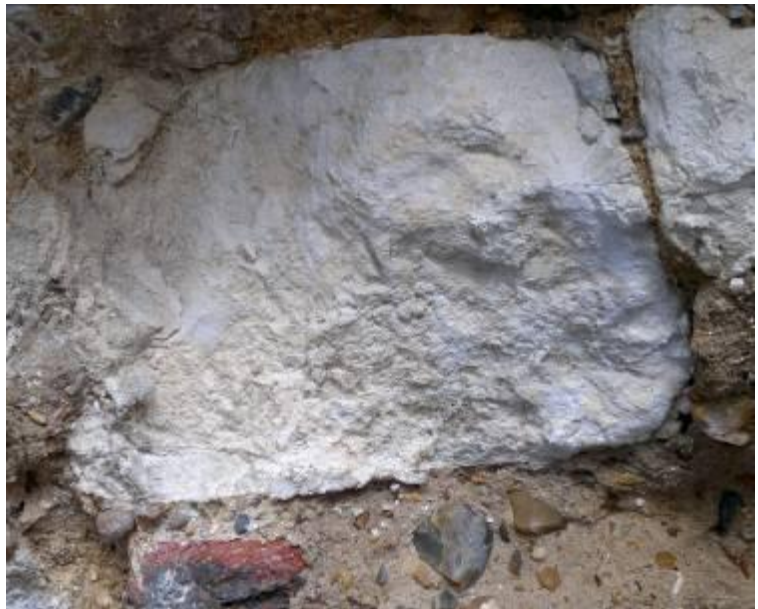
In 2014, second test area was divided into four parts on zone M2 using Calosil nanolime in two suspensions of different concentrations of 5g/L and 25g/L (Calosil E5 and E25 respectively) (Figure 22). On three parts, after pre-wetting with water, three applications of the lower concentration (E5) were followed by three of the higher (E25), applied wet on wet using a large syringe. On the fourth part six applications of E5 only were used. Subsequent examination in early 2015 showed white blooms, penetration failure and the presence of fresh chalk debris (Figure 23).

Figure 23 - Nanolime deposits ('bloom') to substrate surface associated with solvent evaporation/penetration failure

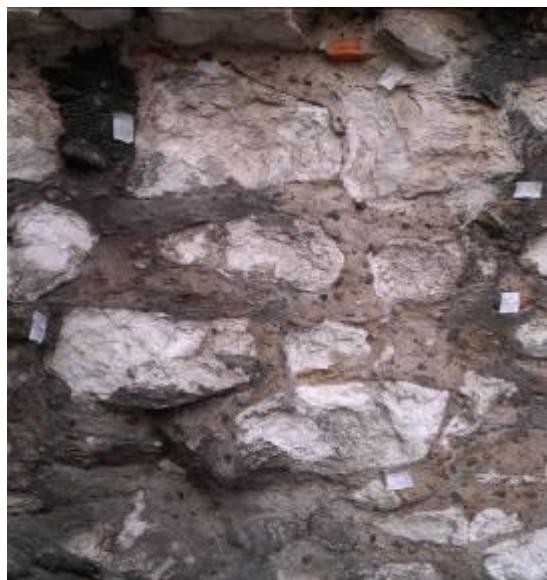
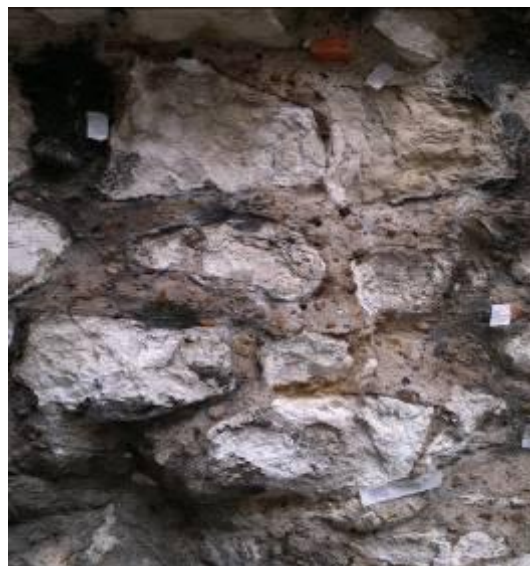
Figure 25 - Before HCT + OH100 treatment

Figure 26 - After HCT + OH100 treatment

A test area of approximately 1m² was selected on the west elevation (Figures 25 and 26) and, following MCC's lab protocol, four applications of the HCT were applied to saturation by brush in succession after drying between each (HCT is rapidly absorbed). This was followed by one application of Conservare Finishing Rinse (aqueous calcium hydroxide, which insolubilizes any excess of water soluble tartrate ions that can interfere with silicate formation) and, after drying, three sprayed saturating applications of Conservare OH100 ethyl silicate consolidant. After 21 days the author executed tape tests on two different blocks (Figures 27 and 28) from the treated areas, which confirmed the consolidating effects noted in the lab tests by MCC. Future testing will increase in the number of applications of the OH100 to achieve the full saturation of the chalk with the ethyl silicate.¹¹

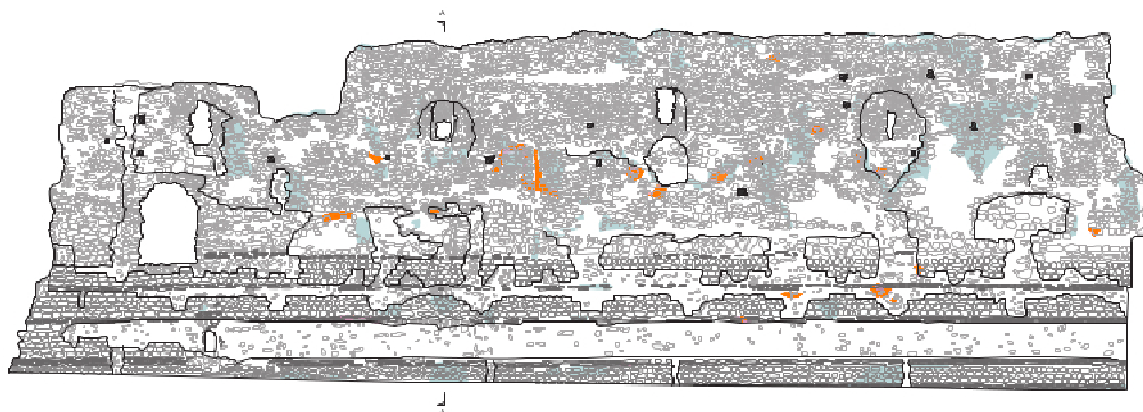
Figure 29 - Coopers Row - Pointing condition survey, west elevation, September 2014

Each year remedial and support lime mortars have been executed. Areas from previous capping and pointing regimes were beginning to fail (both from the 1960s and the 2001 works). A survey was executed in 2014 to assess this in more detail, with such areas annotated with where *significant* and *minor* disruptions to the pointing were (see Figures 29 to 31). One chalk block that had fallen out from the wall near the walkway arch on the west elevation was also re-bedded. Sulphation to the MoW works will not be removed.

Support lime mortars have been primarily executed to areas of *significant* loss/decay including zones M1-M3 and to some of the Roman red tiles R2– R5. The pointing mix is as cited in the Class Schedule Monument Consent (CSMC):

Hydraulic lime (NHL 3.5)	x 1 part
Chardstock sand	x 2.5 parts
Portland stone dust	x 0.5 part

with the addition of washed pea gravel where mortars exceeded 15mm thickness

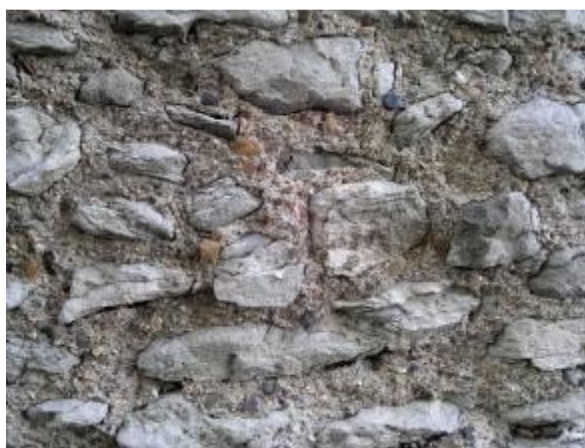
Figure 30 - Minor: losses to ragstone caused by mitigated water egress due to hard cement pointing, west elevation

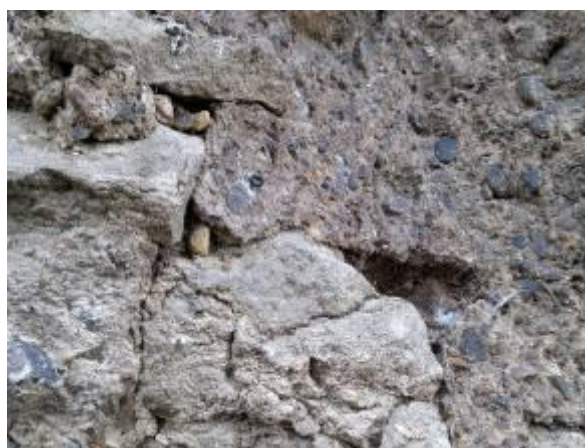
Figure 31 - Significant: losses/voids to/around ragstone due to hard cement pointing inhibiting water egress, west elevation

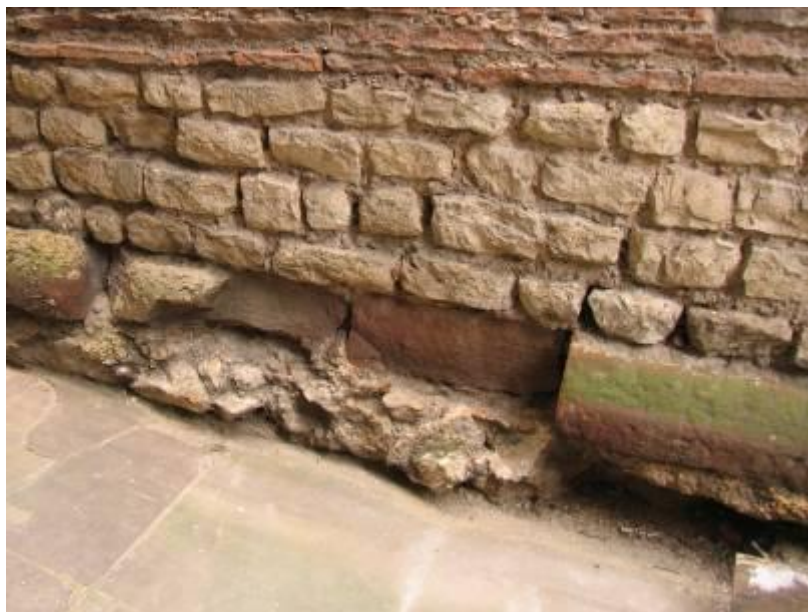
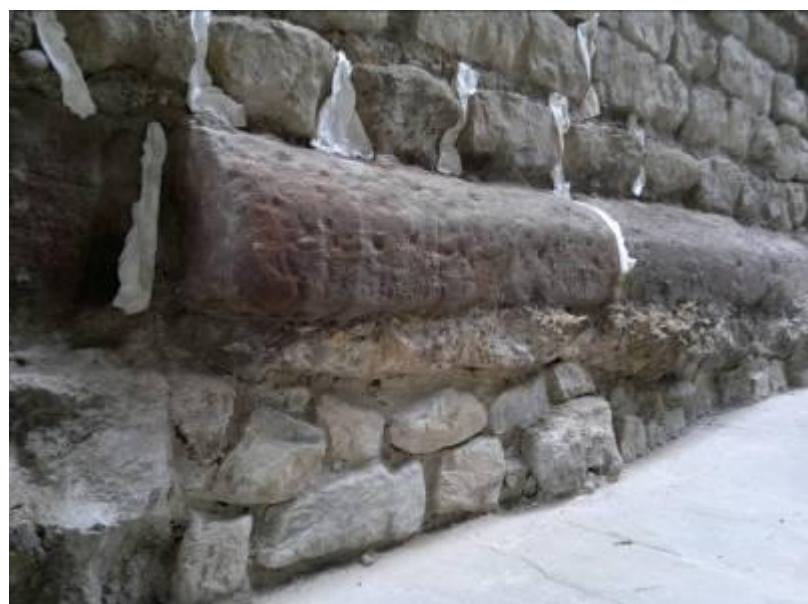
Figure 32 - a) Roman sandstone foundation above modern ground level, east elevation; b) Roman sandstone foundation with lime mortar/ragstone infill to modern ground level, east elevation

Historic pointing losses to the lower levels of the east elevation were evident with large voids regularly interspersed between the Roman block work (some approximately 200mm deep) (see Figures 14 and 15) In 2014 and 2015 the lower Roman courses to a height of approximately 2m were re-pointed using the CSMC lime mortar with Kentish ragstone fragments used as infill.

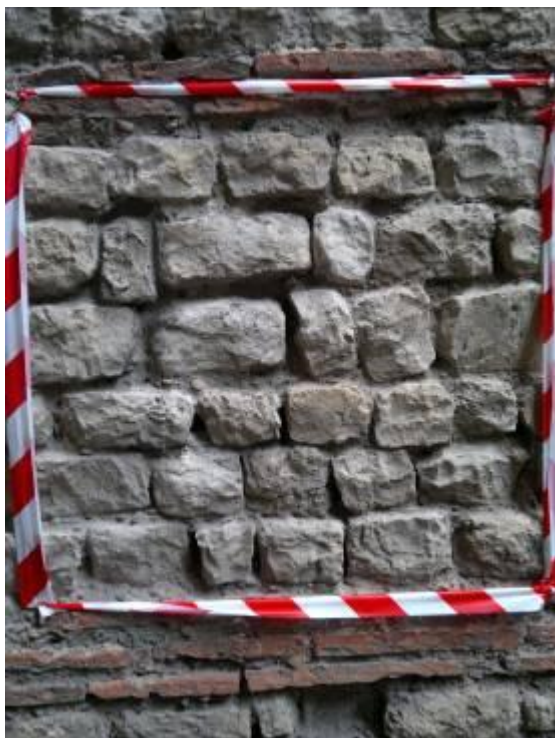
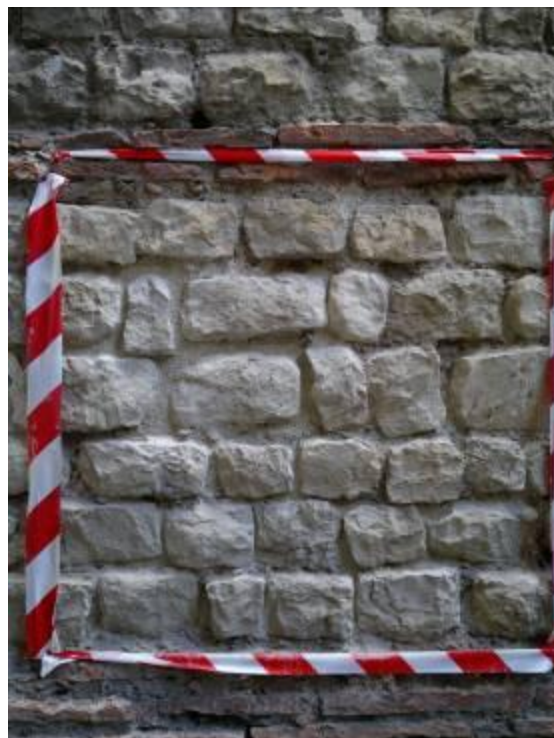
Figure 33 - 1m² “time test” area before raking out and re-pointing, east elevation

Figure 34 - 1m² “time test” area after raking out and re-pointing, east elevation

Historic England had requested some “time-trials” test areas in order to calculate the cost in person-hours to remove all the cement pointing and re-point using lime mortars - two test areas were executed in 2015 (Figures 33 and 34) for raking out/re-pointing to approximately 16 hours per 1m². Each elevation of the wall is approximately 600m² and, as such, has significant cost implications for the client.
