SUMMARY OF THE CONSERVATION TREATMENTS TO COOPER'S ROW, LONDON CITY WALL, UK, 2013-2015

Jonathan Kemp*

The article sets out a record of the conservation methods and materials employed during the works to this section of the wall between 2013 and 2015. A summary of the treatments is included below, with each year's program of works consisting of 40, 30, and 30 days per year respectively.

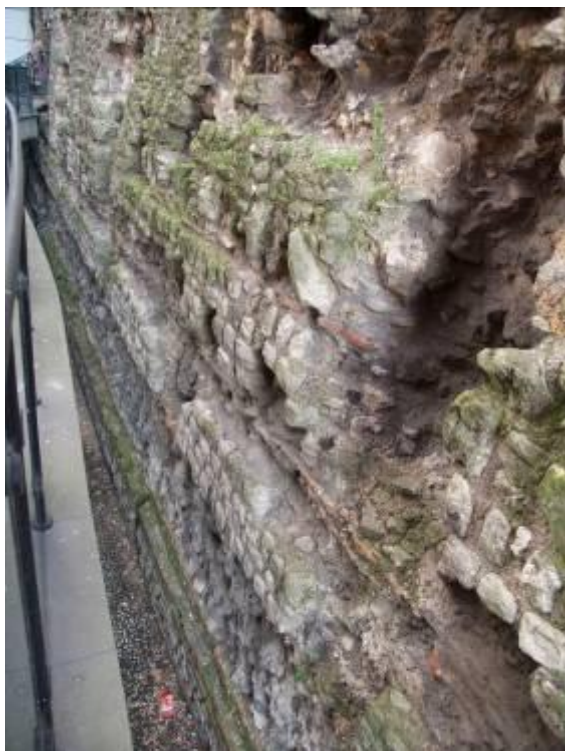
Figure 6 - Looking north along zones R3 - R1, west elevation

Zone R3: There is no sign of active decay, and all mortars appear sound; there is some minor vegetation on the horizontal surface of the plinth course, more noticeably on the tiles, as well as on a small area beneath a gash in the wall.

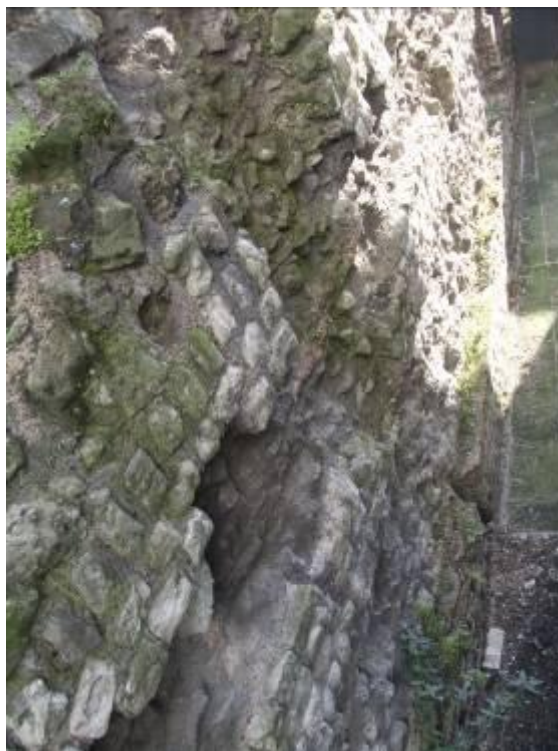
Figure 7 - Looking south along zones R4 - R5, west elevation

Zone R4: There is slightly more deterioration in this area in that less of the facing stone remains, although generally it is well consolidated. There is rather more vegetation on the plinth course and there are some open joints. There is some sulphation in protected areas, and the second level of the Roman tiles exhibit historic damage. There is algae and moss on the upper facing surfaces of the tiles.

Zone R5: This is in good condition, with only minor vegetation to the tile course.

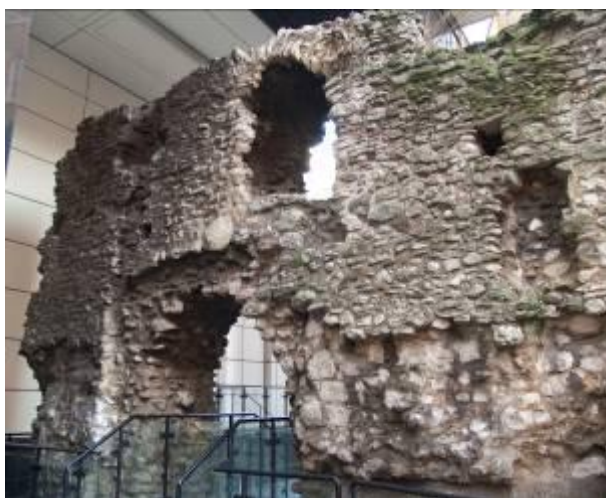
Zone M1: The capping is intact and there is little vegetation except at the extreme southern edge where buddleia has become established. To the north of the doorway, the stonework is sulphated and well consolidated; at the bottom of this section the core is exposed and chalk blocks (just to the north of the doorway) exhibit surface decay. The doorway is sound although it has black sulphation on all areas. The upper opening is also sound but there are a small number of chalk blocks in the soffit that have some surface decay. There are a number of different mortars evident. Sections of the chalk blocks continue to deteriorate despite having been consolidated with limewater and limewash (2001).

Zone M2: Overall this zone is well consolidated at the upper level but cracks in the pointing are being colonised by bio-infestation. The upper opening is a roost for pigeons and has accumulated guano, as have many of the horizontal surfaces on this elevation of the wall. The arch of the opening has some continuing deterioration, and areas of the exposed chalk core continue to deteriorate even after consolidation in 2001 (Figure 10).

Figure 8 - Looking north along zones M2 - M1, west elevation

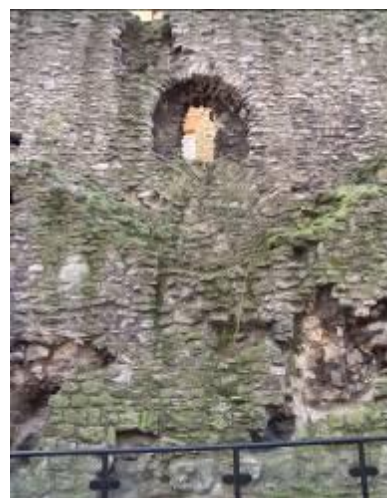
Zone M3: There is some cracking between stones and the MoW mortar in this zone (Figure 12). Vegetation has become established on the horizontal surfaces of the V-shaped offset, including moss and buddleia. Just beneath this offset on the extreme north of the zone is an area of exposed core where pigeons are roosting and appear to have pecked at the soft stone; an adjacent area of chalk blocks suffers decay and adjacent areas of the MoW consolidated core exhibit sulphation (Figure 13).

Figure 9 - Zone M3, west elevation

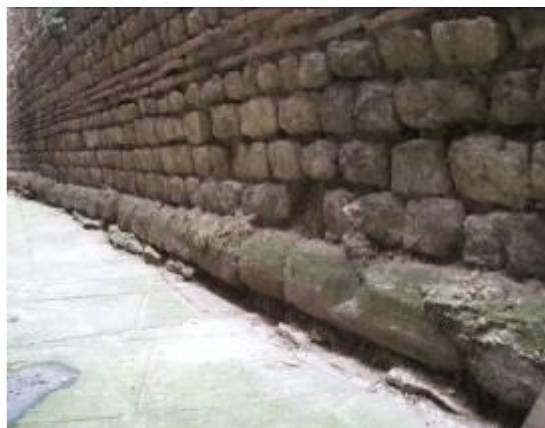
Zone R3/R5: The condition of the ashlar appears good. Sandstone foundation stones are visible along most of the wall. The pointing is missing along much of *R1/R2* with very deep voids apparent (Figures 14 and 15) There is some vegetation on the horizontal surfaces, including buddleia

Figure 15 - Looking south along R3 - R5, Roman sandstone foundation, east elevation

Historic pointing losses to the lower levels of the east elevation were evident with large voids regularly interspersed between the Roman block work (some approximately 200mm deep) (see Figures 14 and 15) In 2014 and 2015 the lower Roman courses to a height of approximately 2m were re-pointed using the CSMC lime mortar with Kentish ragstone fragments used as infill.

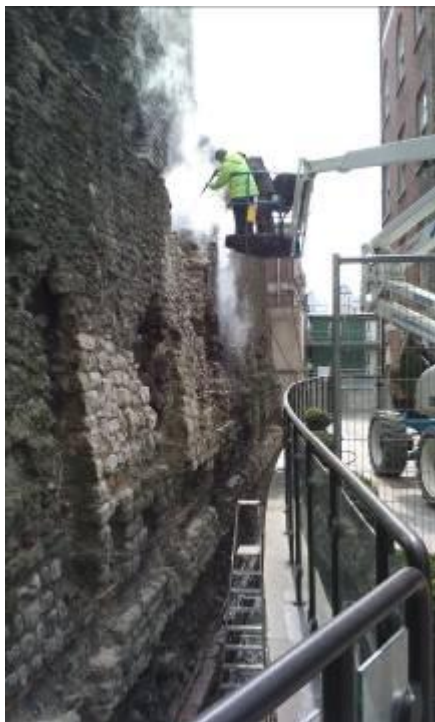
Figure 18 - The author using conservation-grade Thermatech® equipment on the west elevation

In 2013 a ThermaTech® super-heated water cleaner was used from a boom lift ('cherry picker') on the west elevation to clear the cyanobacteria, algae and moss infestations. This operation, as well as removing all extant bio-infestations, effectively sterilised the treated surfaces which, when combined with the annual application of an Historic England approved boron-based biocide (Wykabor 10) has led to, in subsequent years, a dramatic lessening of such infestations (Figures 18 and 19).⁷ In 2014 and 2015 cleaning was executed using only conservation-grade steam cleaners.

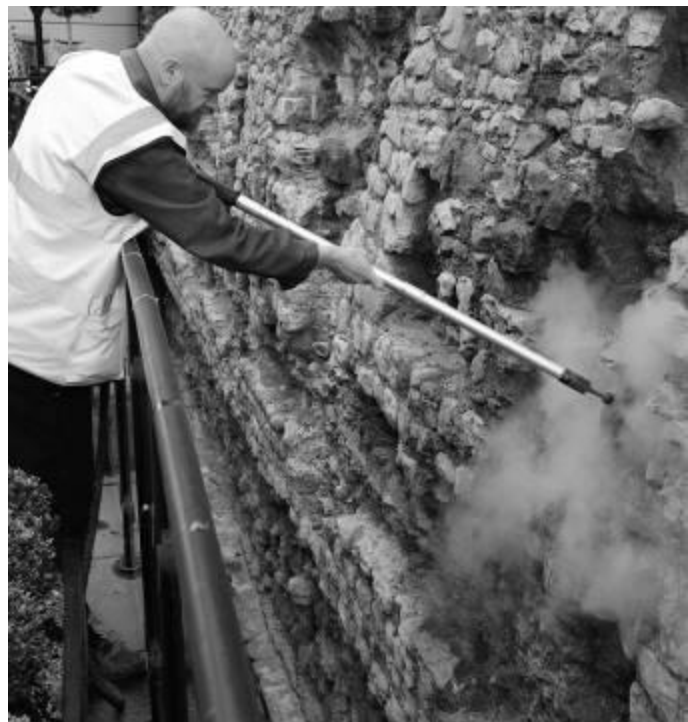
Figure 19 - The author using conservation-grade steam cleaning equipment on the west elevation

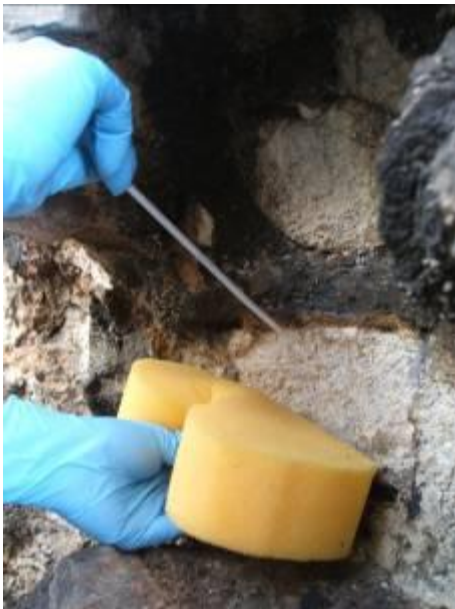
In 2014, second test area was divided into four parts on zone M2 using Calosil nanolime in two suspensions of different concentrations of 5g/L and 25g/L (Calosil E5 and E25 respectively) (Figure 22). On three parts, after pre-wetting with water, three applications of the lower concentration (E5) were followed by three of the higher (E25), applied wet on wet using a large syringe. On the fourth part six applications of E5 only were used. Subsequent examination in early 2015 showed white blooms, penetration failure and the presence of fresh chalk debris (Figure 23).

Figure 22 - Applying Calosil E25 by pipette

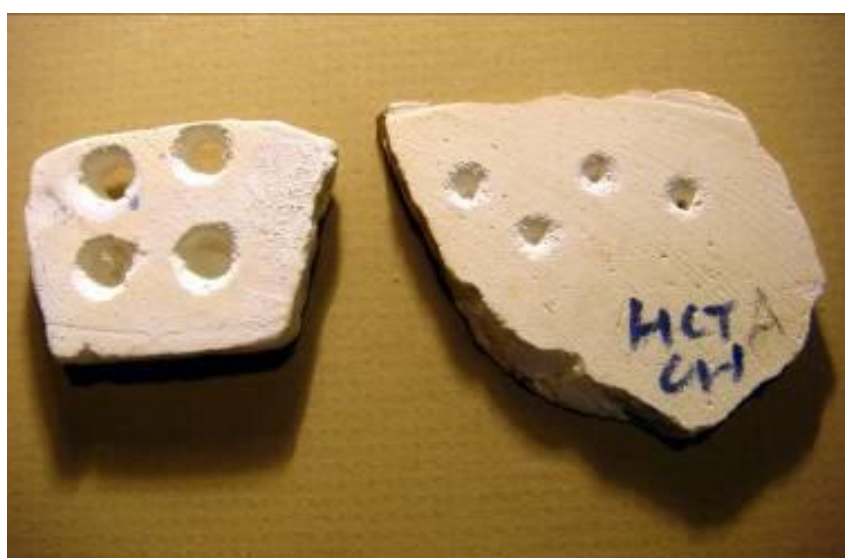
Figure 24 - Visual comparison of untreated control chalk specimen (left) and HCT +OH100 treated chalk sample (right) after micro-abrasion tests (courtesy of Irving Slavid, MCC)

After testing with Conservare HCT, MCC reported that using the HCT treatment alone when compared to a control showed either no change or even worse results after testing for abrasion resistance. However, samples treated with HCT followed by an ethyl silicate, Conservare OH100, exhibited approximately 100% strength increase.

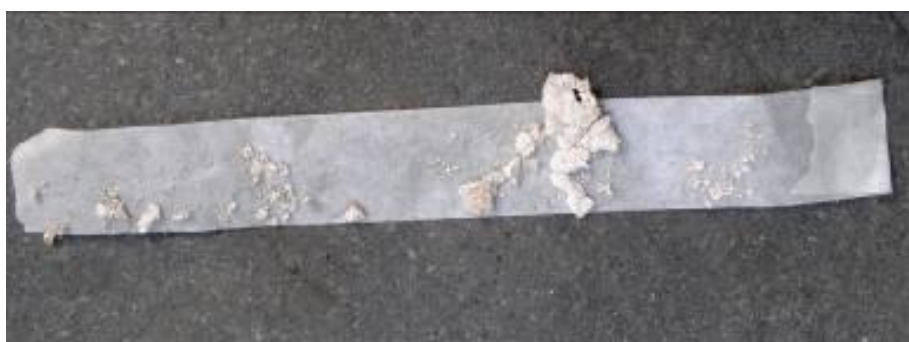
Figure 27 - Tape test on chalk before HCT + OH100 treatment

A test area of approximately 1m² was selected on the west elevation (Figures 25 and 26) and, following MCC's lab protocol, four applications of the HCT were applied to saturation by brush in succession after drying between each (HCT is rapidly absorbed). This was followed by one application of Conservare Finishing Rinse (aqueous calcium hydroxide, which insolubilizes any excess of water soluble tartrate ions that can interfere with silicate formation) and, after drying, three sprayed saturating applications of Conservare OH100 ethyl silicate consolidant. After 21 days the author executed tape tests on two different blocks (Figures 27 and 28) from the treated areas, which confirmed the consolidating effects noted in the lab tests by MCC. Future testing will increase in the number of applications of the OH100 to achieve the full saturation of the chalk with the ethyl silicate.¹¹

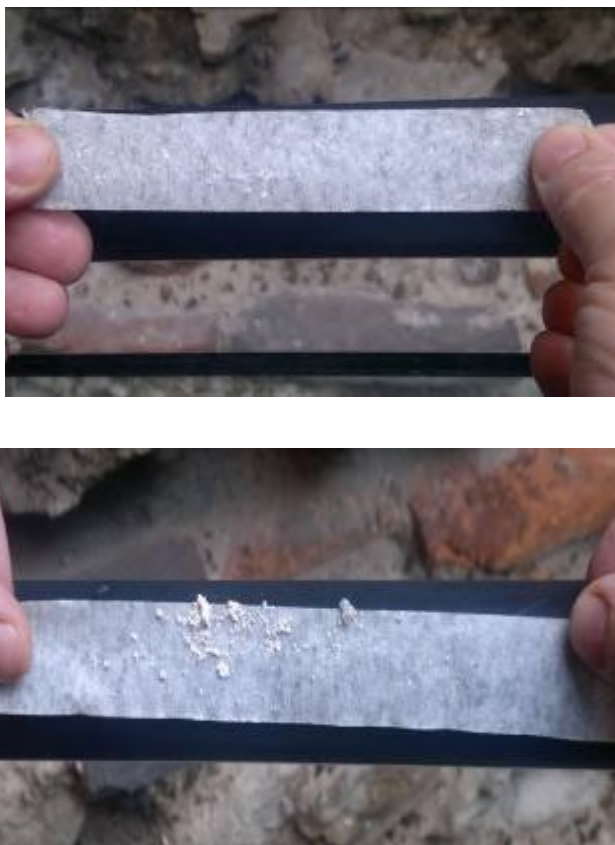
Figure 28 - Tape tests on chalk after HCT + OH100 treatment
